ACT WATER REPORT 2008–2009

The **ACT Water Report 2008–2009** provides important information about our waterways and the impact of the urban, rural, forestry and conservation land practices in the ACT.

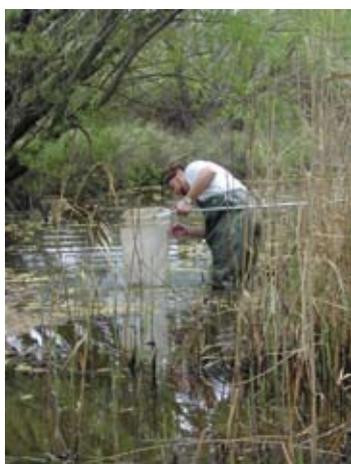
*Seeing who's home...
Collecting water bugs to
assess water quality and
habitat conditions*

Water chemistry analysis such as pH, total phosphorus and dissolved oxygen provides a snapshot of the water quality at the time when the sample is taken. Biological assessment, in this case the sampling of waterbugs (benthic macroinvertebrates), can indicate much about the water quality over time and show what kind of environment the water and its waterway provide for animals to live in.

Macroinvertebrate biological assessment is based on a comparison between a tally of the range of waterbugs found at a site with those predicted to occur there. If all those animals expected at a site actually occur there, the site is judged to be in good condition. Conversely the absence of expected animals indicates a site has been disturbed. The rating scale for AUSRIVAS outputs is presented below (Table 17). A full explanation of the AUSRIVAS biological assessment method for the ACT is available from www.ausrivas.canberra.edu.au and the full biological assessment reports are available on request from Water Resources.

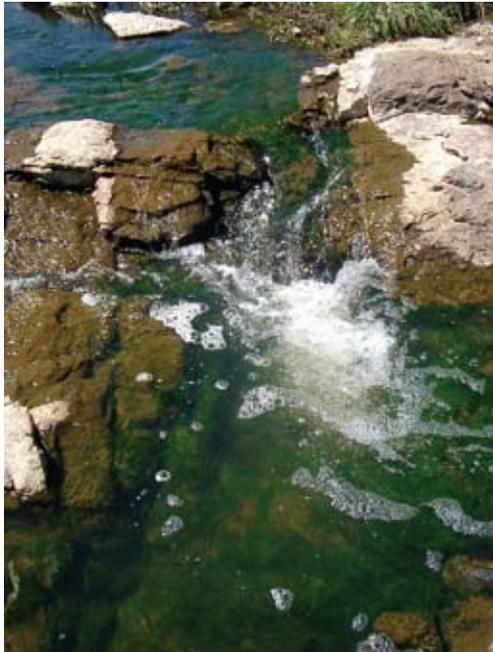
Ginninderra Creek is constrained as it flows through urban areas. Poor riparian vegetation encourages compensatory growth of filamentous algae.

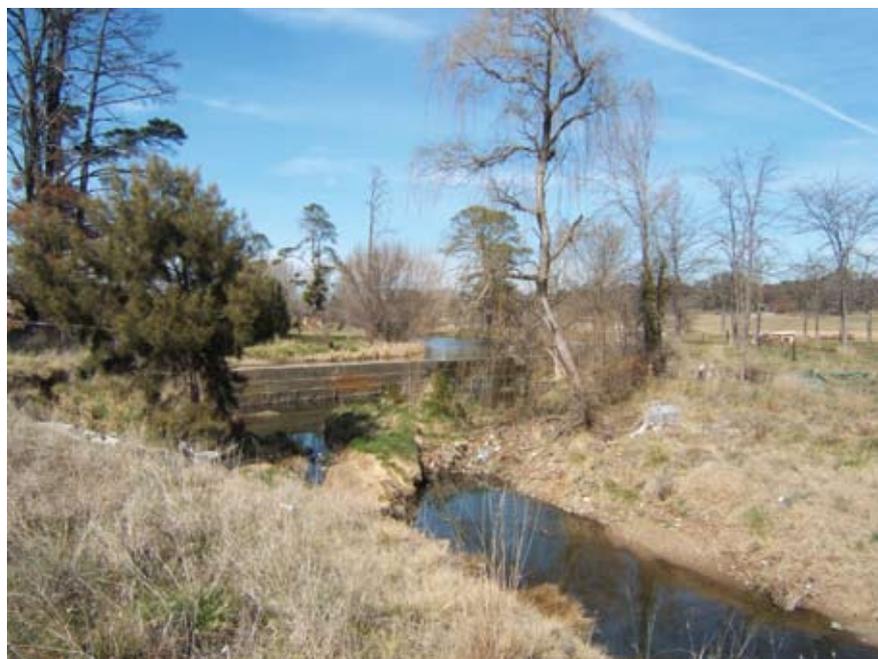
Yarralumla Creek, at the sewer main crossing in the horse paddocks near Cotter Rd bridge.

Site 189 (Figure 7) on Yarralumla Creek is only sampled using the AUSRIVAS macroinvertebrate rapid bioassessment protocol in spring and autumn. Water quality results presented for this site are those sampled in conjunction with the macroinvertebrate sampling. This creek is mostly a concrete lined drain meandering through the urban areas of Phillip and Woden but becomes more creek-like as it crosses the horse paddocks before joining the Molonglo River below Scrivener Dam. Water quality in April reflects local infrastructure work and low rainfall with hot weather in February and March. The dissolved oxygen result coincides with a report of very dense filamentous algal growth, which may lead to localised oxygen depletion. With much of Yarralumla Creek confined to concrete drain lines, and the lower creek in horse paddocks, the consistent severely impaired AUSRIVAS rating is unlikely to improve.

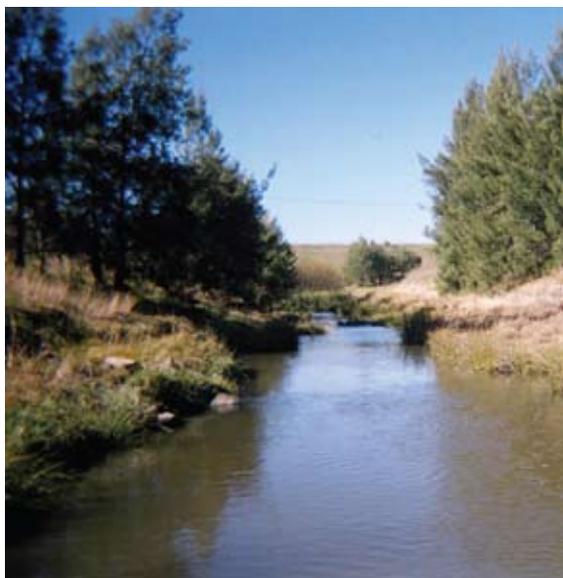
Tuggeranong Creek, looking back towards the Lake Tuggeranong wall, May 2007.

Site 58 (Figure 7) on Tuggeranong Creek is only sampled using the AUSRIVAS macroinvertebrate rapid bioassessment protocol in spring and autumn. Water quality results presented for this site are those sampled in conjunction with the macroinvertebrate sampling. This site is in the creek downstream of Lake Tuggeranong. Although Lake Tuggeranong helps prevent sediments and pollutants from reaching this section of the creek habitat, the surrounding land use of grazing and the disturbance by bushfires means this site is susceptible to degradation. The turbidity may be associated with sediment loads associated with post-storm flows.

The AUSRIVAS rating for this small waterway is quite variable. The creek vegetation has recovered from the bushfire, but the flow regime through Lake Tuggeranong is partly dependent on storms, and the test site may become a pool for significant periods. While the rating in autumn 2008 was at reference, it had slipped to severely impaired in spring 2008, and returned to significantly impaired in autumn 2009, most probably in response to water level and flow rate fluctuations.

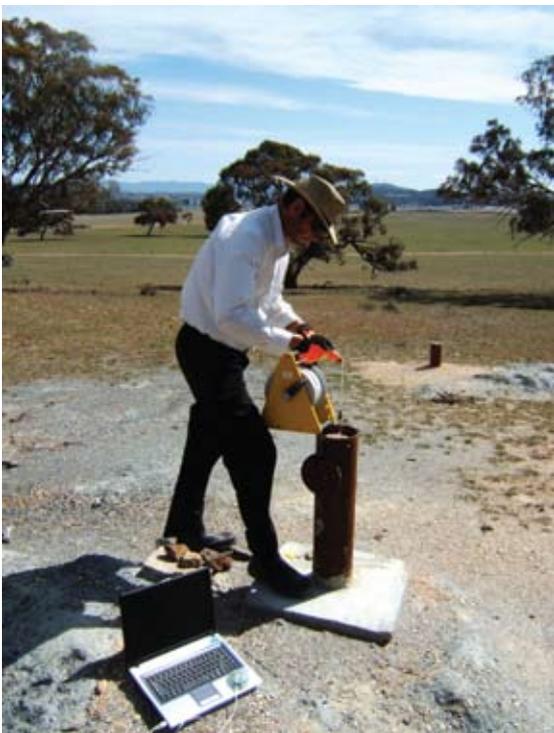
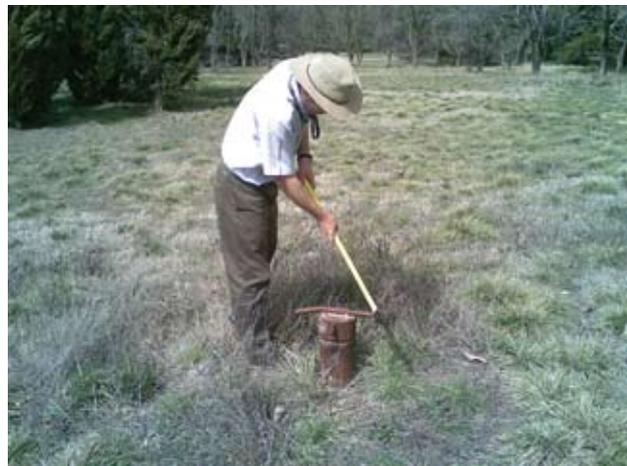
Monitoring the aquifer (left). Environmental Protection officer investigating an abandoned bore in the Capital Precinct (above)

Environment Protection and Water Resources currently maintains 14 dedicated monitoring bores, with information from another 6 sites coming from interested groundwater abstracters. The purpose of these monitoring bores is to gather information about the transmissivity (capacity for water to move through the aquifer), hydraulic conductivity, storage capacity potential, and recharge rates of the various aquifer types within water management areas. Monitoring of the aquifer recharge response to rainfall is seen as a critical activity to be able to quantify potential effects of changed rainfall patterns expected from climate change.

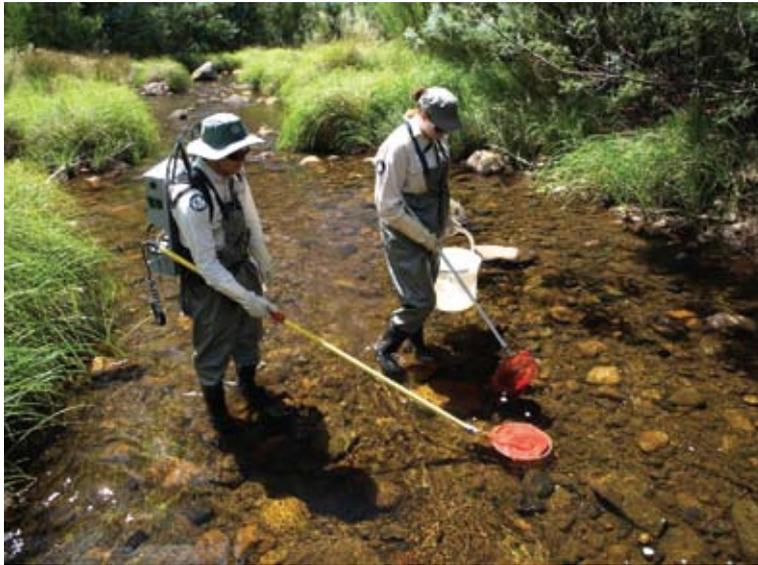
Parks, Conservation and Lands staff backpack electro-fishing on the Cotter River in 2009. Photo by Mark Jakobsons
